Activity report of NICT/Kashima VLBI group

NICT Kashima Space Technology Center

34m Antenna Main Reflector backup structure

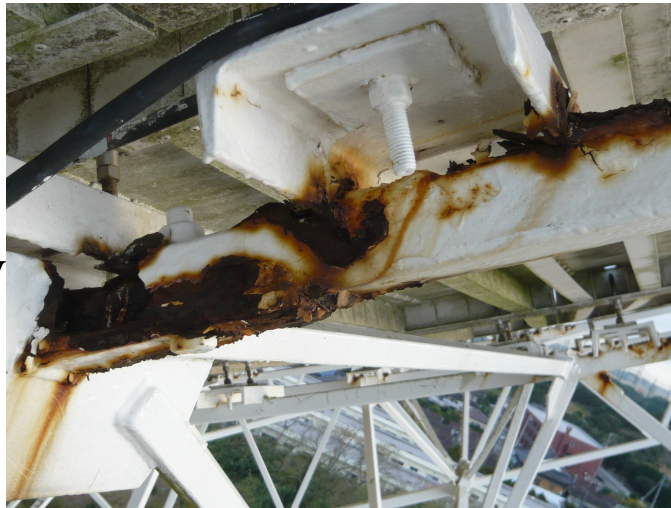
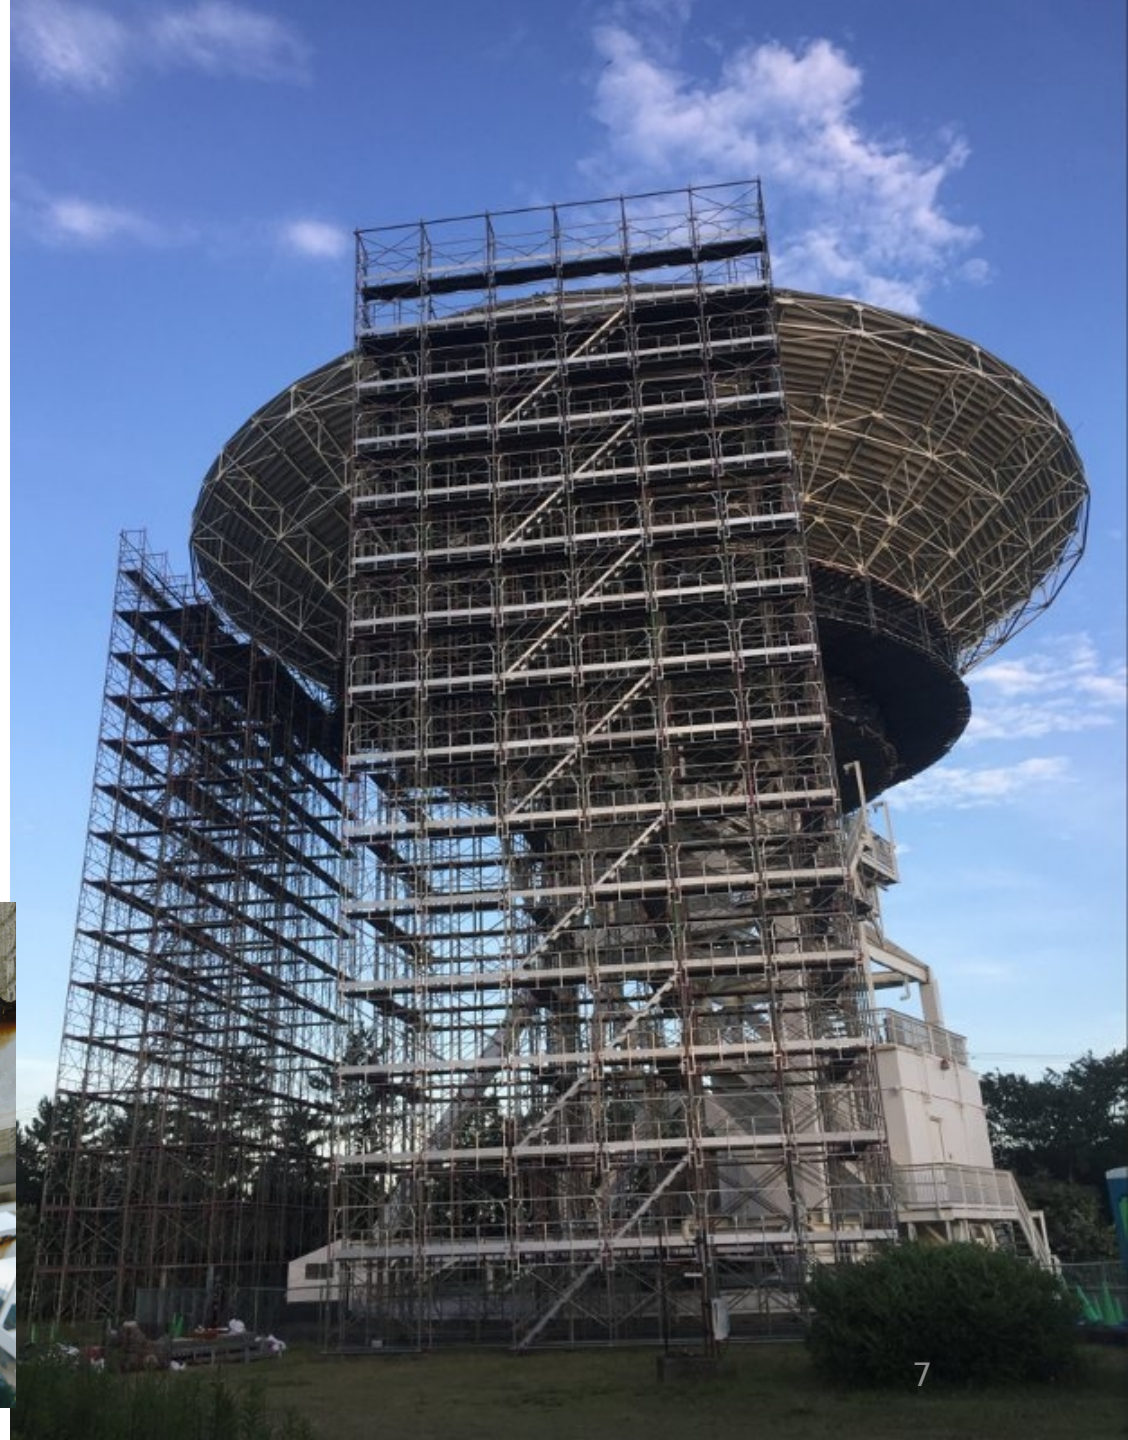
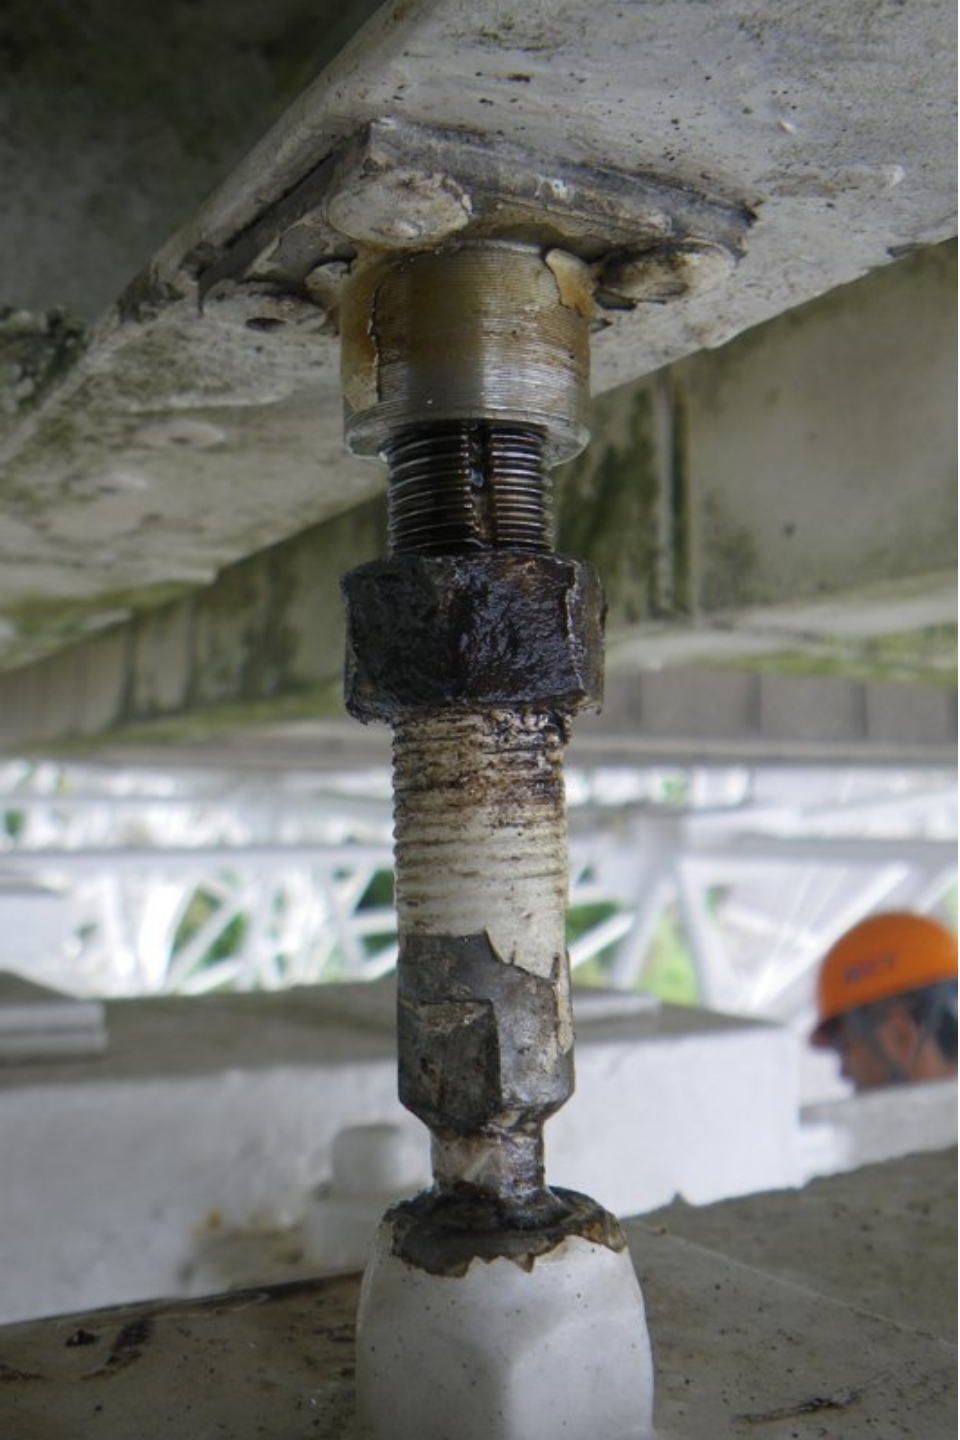
For safety reason, repair work of corrosion damage at backup structure has been urgent issue.

Example of the most heavily damaged steel pipe.

(Photo taken in Nov. 2016)

- Repair work period: May-Sep. 2018
- Some part of steel pipes had to be cut & replaced.
- Precision of reflector height might be changed.
⇒ Reflector panel adjustment is necessary!

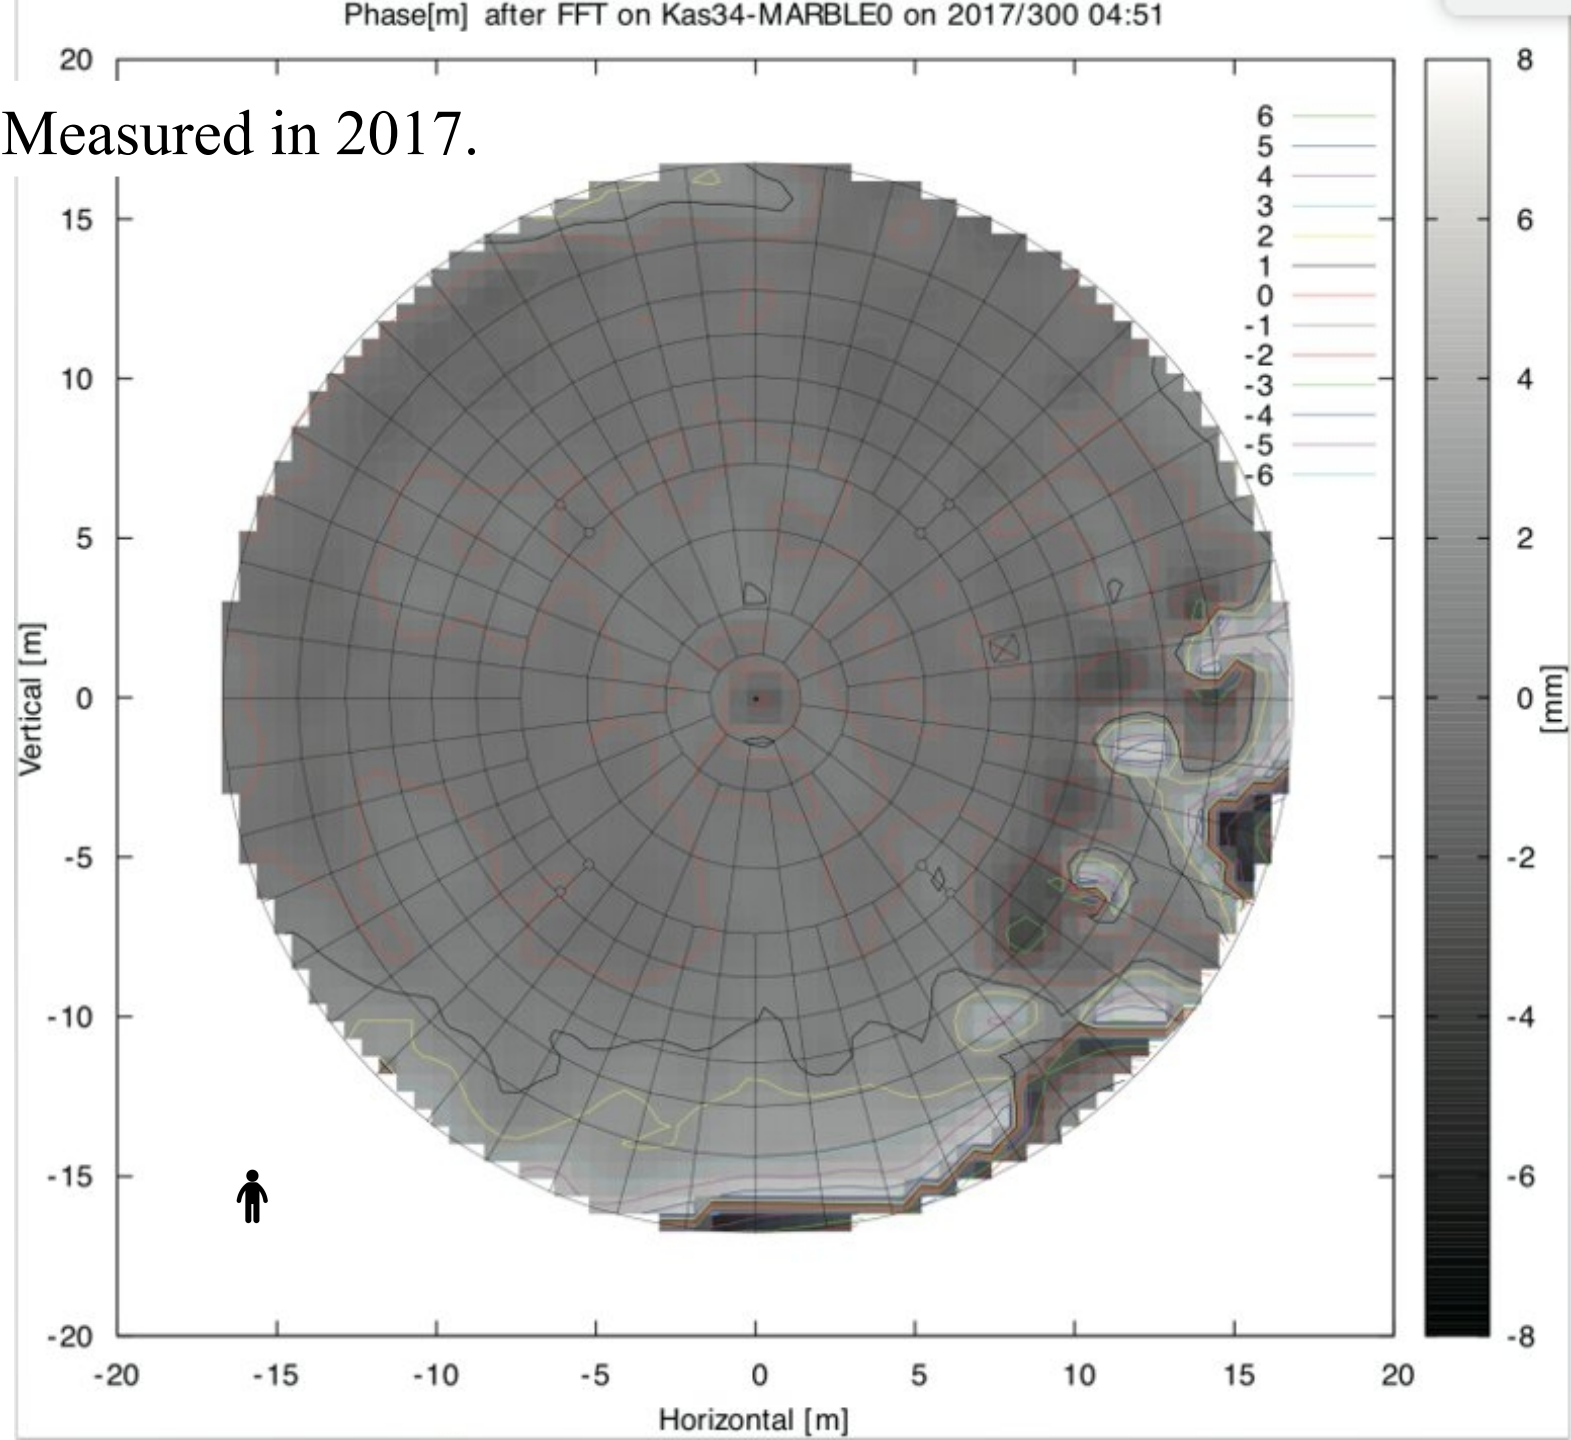
Initial surface flatness Measured in 2017.

Deformations are appeared
at lower right side.

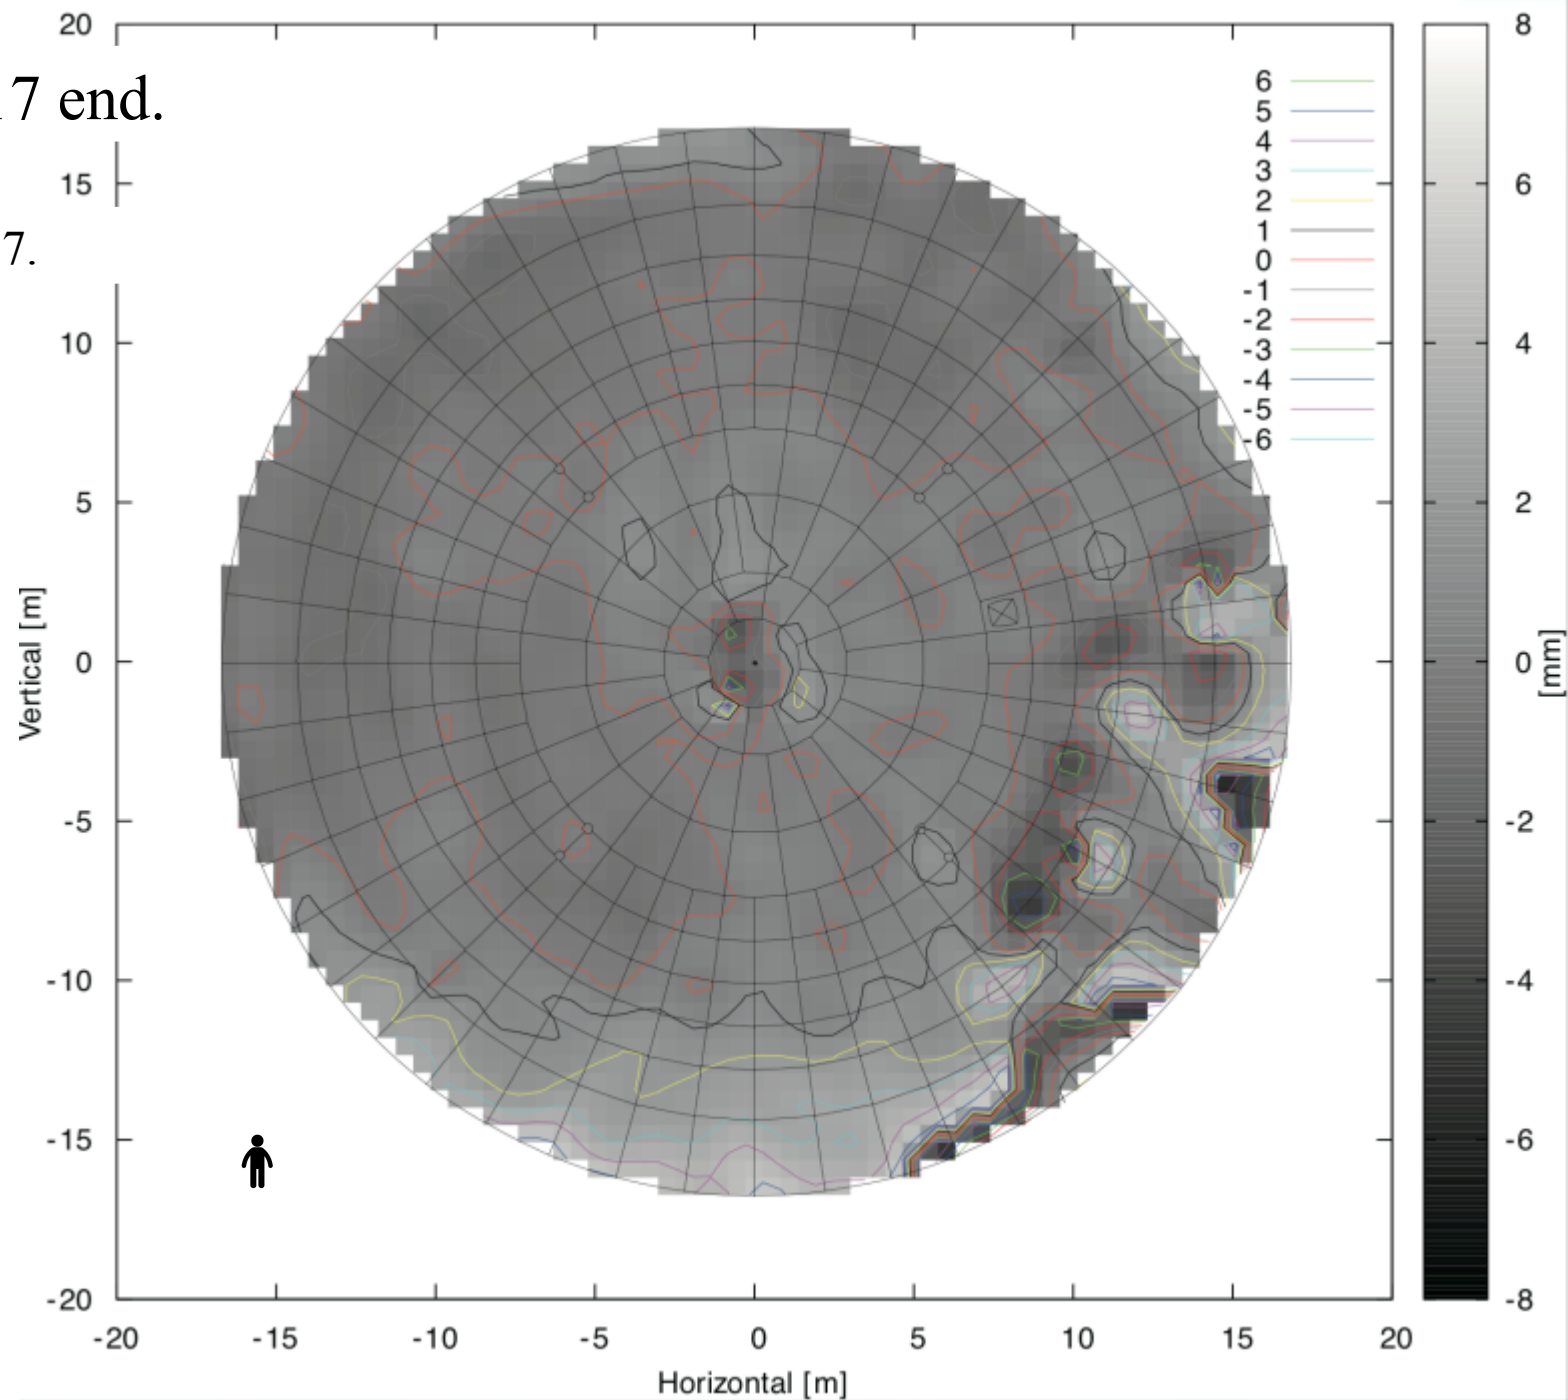
Surface flatness in 2017 end.

Bottom edge was fixed in 2017.

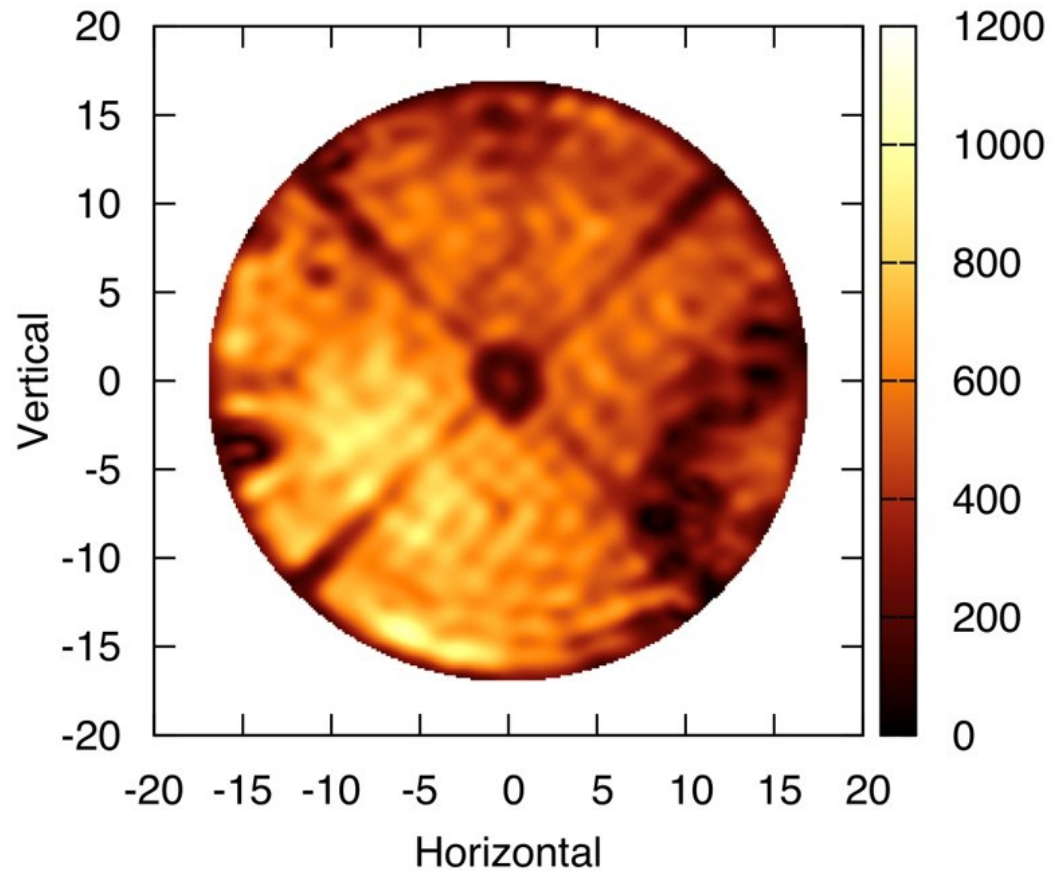
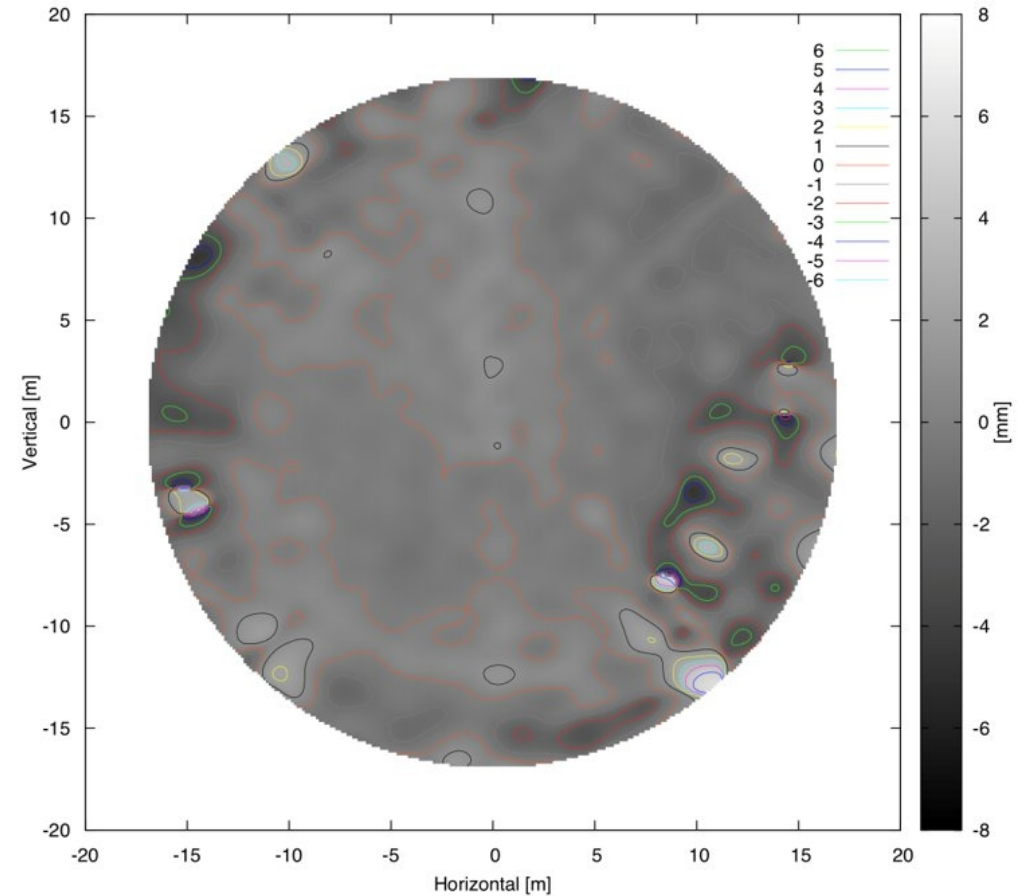
Measurement just after
the backup structure repair work (9th Sep. 2018)

Additional deformations were occurred by the repair work in the summer of 2018.

Height variation has been converged within 1mm peak-peak.
