Activity report of NICT/Kashima VLBI group

NICT Kashima Space Technology Center

34m Antenna Main Reflector backup structure

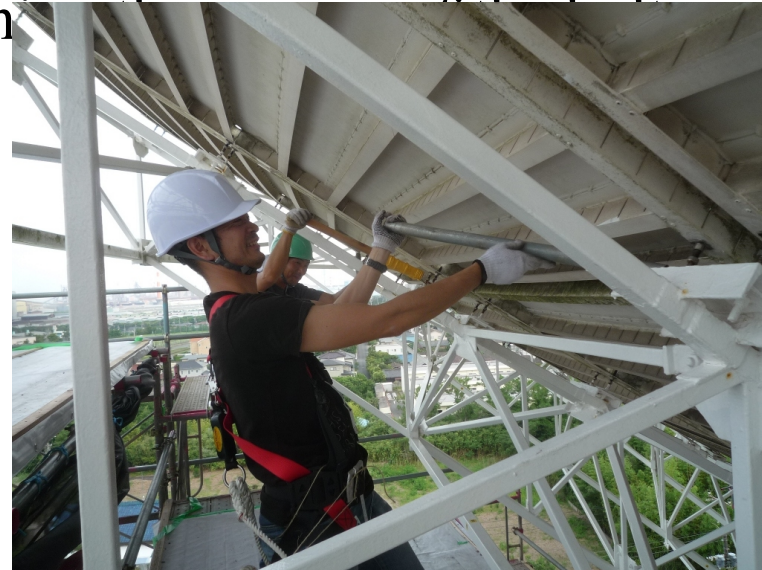
Reflector panel adjustment mechanism exists in Kashima 34m antenna. However it has never been used for a long time after the construction.

They are fixed by nut to avoid unintended changes.

- Removing painting on the bolt
- Releasing nut.
- Cleaning and lubrication.

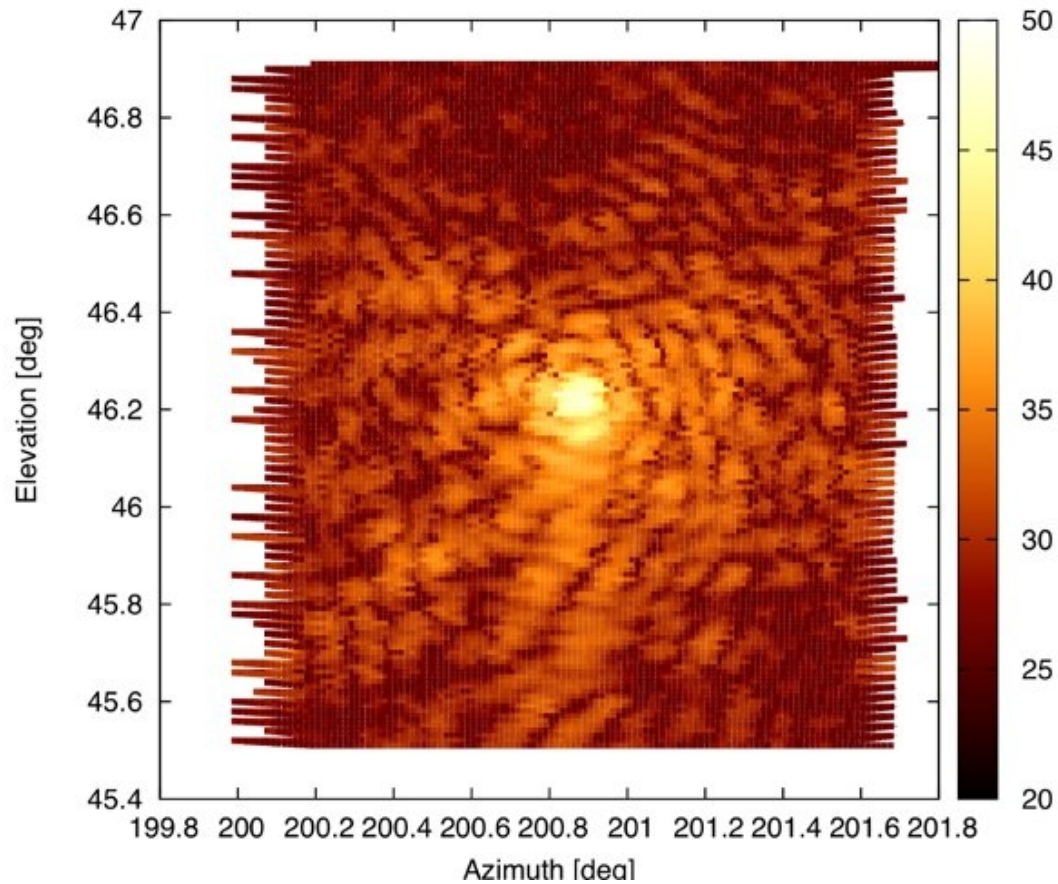
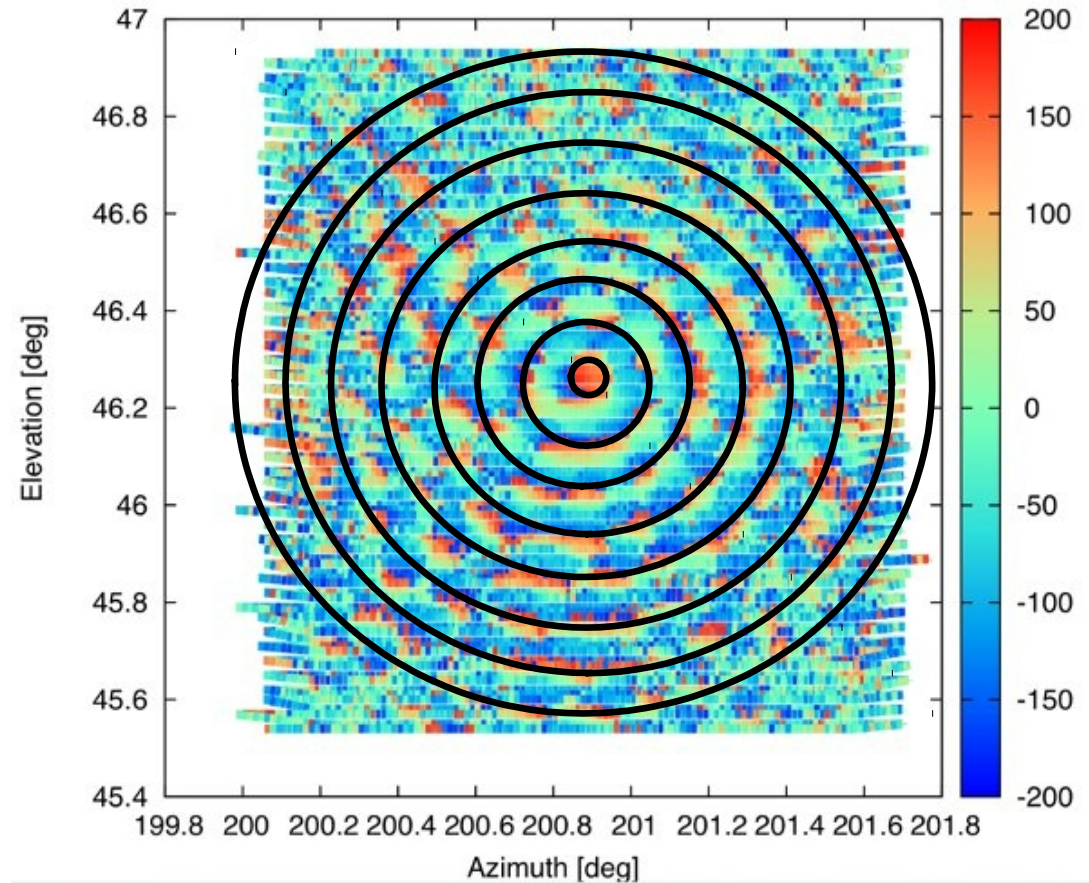
2017/300 04:51

Initial surface flatness Measured in 2017.
